**Flood Control Project Maintenance
Levee Inspections**

Maintenance Issue Types Only, Levee Inspection Report By Mile - Fall 2019

Tehama County Flood Control and Water Conservation District

Waterway	Bank	Unit Miles	Inspection Start/End	Inspector
Unit No. 01 Deer Creek	Left	4.22	10/30/2019 10/30/2019	Makar Sokol

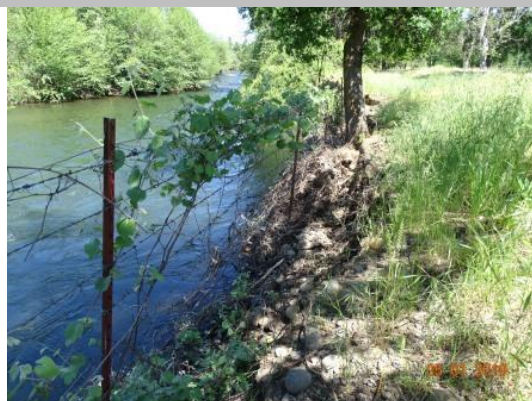
Photo 2 of 3 : FA_2019_NA0019_78_42_20190822_00015.jpg

LM Start	1.55	Rating **	A/W	Issue No.	42 (cont)
LM End	1.58	Issue Type +	Ma	Location *	WS
Category	Earthen Levee			GPS Latitude/Longitude	
				Start	End
Item	Erosion / Bank Caving			39.969193°	39.969052°
				-122.008458°	-122.008920°
DWR ID	DWR_NA0019_01_s_2017_42				
Comment Code					
E2 : Schedule repair of erosion site prior to the next inspection.					
Inspector Comment

View of the erosion along the waterside toe. Spring 2019.

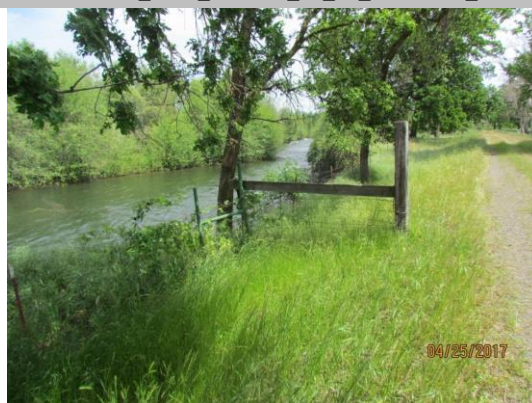
Photo 3 of 3 : FA_2019_NA0019_78_42_20190822_00014.jpg

View of the erosion along the waterside toe.

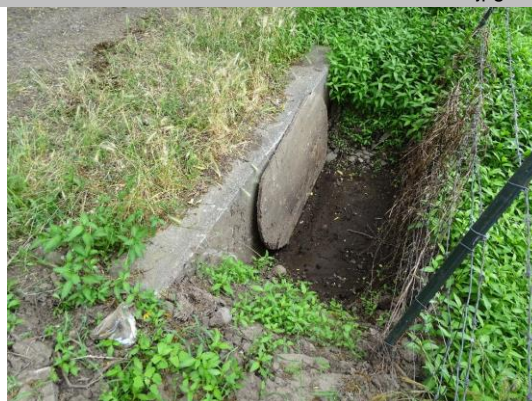
Photo 1 of 3 : UCIP_FA_2019_54006_79261.jpg

Comment Code						
Inspector Comment						
DS_ID:20770 FS_ID:54006 EP_NO: N/A Repair Type: Non-Urgent Crossing Status: Found UCIP Comments: 05/14/2019 Pipe end on WS has been cleared from sediment buildup to let flap gate close properly, but the rest of pipe is still silted inside. Flap gate was fixed and operable now. (O.Yakimov - DWR UCIP)10/15/2018 Flap gate on WS end stuck open. Lower part of pipe is silted that makes impossible flap gate to fully close. Needs sediment cleanup around pipe outlet on WS. (O.Yakimov - DWR)12/05/2016 Sediment buildup inside pipe (see photo) and sediment buildup on WS blocking flap gate. Crossing has been downgraded from Urgent to Non-Urgent crossing was closed on both WS and LS. (O. Magana - DWR UCIP)10/02/2013 Flapgate blocked by soil buildup. (W. Wylie - DWR UCIP) FIELD_STRUCT_DESC: 24-inch steel drainage pipe through the levee, 1.5 feet below the crown. Flap gate on the waterside (WS) toe. [Additional Reference(s): DWR Levee Log, 1992. USACE Sacramento O&M Manual Unit 509, March 1957, As-built drawings available 50-4-2394 (Station 185+40)]. FS Date: 5/14/2019 3:33:54 PM

LS view of concrete headwall with wood panel blocking opening

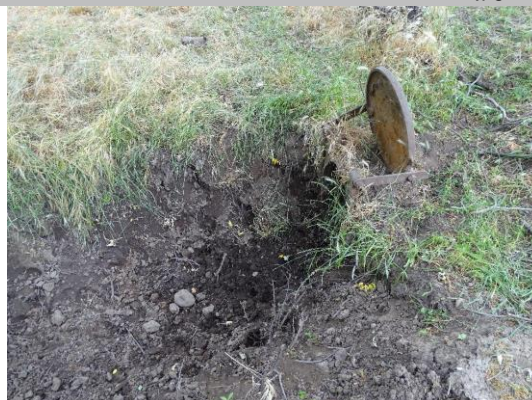
Photo 2 of 3 : UCIP_FA_2019_54006_79262.jpg

Flap gate at WS toe

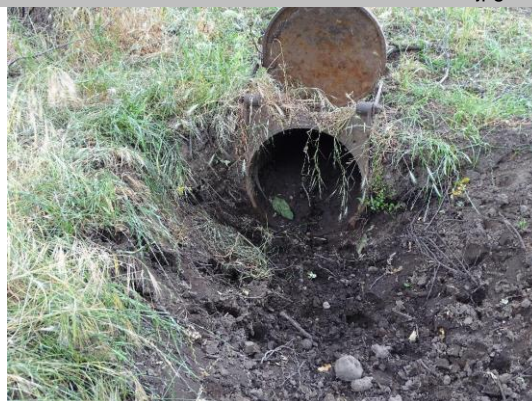
Photo 3 of 3 : UCIP_FA_2019_54006_79263.jpg

Comment Code						
Inspector Comment						
DS_ID:20770 FS_ID:54006 EP_NO: N/A Repair Type: Non-Urgent Crossing Status: Found UCIP Comments: 05/14/2019 Pipe end on WS has been cleared from sediment buildup to let flap gate close properly, but the rest of pipe is still silted inside. Flap gate was fixed and operable now. (O.Yakimov - DWR UCIP)10/15/2018 Flap gate on WS end stuck open. Lower part of pipe is silted that makes impossible flap gate to fully close. Needs sediment cleanup around pipe outlet on WS. (O.Yakimov - DWR)12/05/2016 Sediment buildup inside pipe (see photo) and sediment buildup on WS blocking flap gate. Crossing has been downgraded from Urgent to Non-Urgent crossing was closed on both WS and LS. (O. Magana - DWR UCIP)10/02/2013 Flapgate blocked by soil buildup. (W. Wylie - DWR UCIP) FIELD_STRUCT_DESC: 24-inch steel drainage pipe through the levee, 1.5 feet below the crown. Flap gate on the waterside (WS) toe. [Additional Reference(s): DWR Levee Log, 1992. USACE Sacramento O&M Manual Unit 509, March 1957, As-built drawings available 50-4-2394 (Station 185+40)]. FS Date: 5/14/2019 3:33:54 PM

Sediment was cleared around flap gate

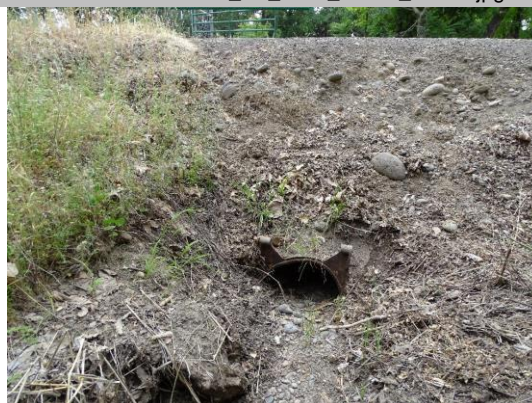
Photo 2 of 3 : UCIP_FA_2019_54008_79271.jpg

Comment Code						
Inspector Comment						
DS_ID:20769 FS_ID:54008 EP_NO: N/A Repair Type: Urgent Crossing Status: Found UCIP Comments: 05/14/2019 Same as last inspection. Flapgate on WS is missing, pipe partially blocked with sedimen. (O.Yakimov - DWR UCIP)10/15/2018 Flapgate on WS is missing, pipe partially blocked with sediment. (O.Yakimov - DWR)12/05/2016 same as last inspection. Crossing remains "Urgent" WS opened during flood season due to damaged flap gate. (O. Magana - DWR UCIP)10/02/2013 Flapgate missing or burried on WS toe. Pipe partially blocked by soil on WS toe. (W. Wylie - DWR UCIP) FIELD_STRUCT_DESC: 24-inch corrugated metal drainage pipe through the levee, 7 feet below the crown. Flap gate located on the waterside (WS) end. A 5-foot by 5-foot concrete control structure located on the landside (LS) toe. [Additional Reference(s): DWR Levee Log, 1992. USACE Sacramento O&M Manual Unit 509, March 1957, As-built drawing no. 50-4-2394 (Station 176+10)]. FS Date: 5/14/2019 4:05:54 PM

Partially silted pipe at WS toe missing flap gate

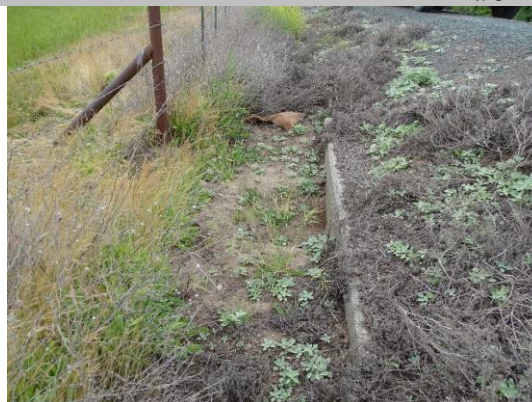
Photo 1 of 3 : UCIP_FA_2019_54011_79272.jpg

Comment Code					
Inspector Comment					
DS_ID:20877 FS_ID:54011 EP_NO: N/A Repair Type: Non-Urgent Crossing Status: Found UCIP Comments: 05/14/2019 Pipe outlet and headwall were excavated to evaluate pipe condition. Pipe is completely filled with soil that makes impossible to clear it for DMP internal video inspection. Pipe may be rehabilitated under DMP Phase II or removed. Excavated soil was backfilled. (O.Yakimov - DWR UCIP)Headwall covered with soil. Needs to be cleared at both ends. FIELD_STRUCT_DESC: 24-inch corrugated metal pipe through the levee 5-feet below the crown. Calco automatic drainage gate. Originally included in O+M manual (1957). As-built drawings available 50-4-2394. FS Date: 5/14/2019 8:37:31 AM

Concrete headwall on LS toe

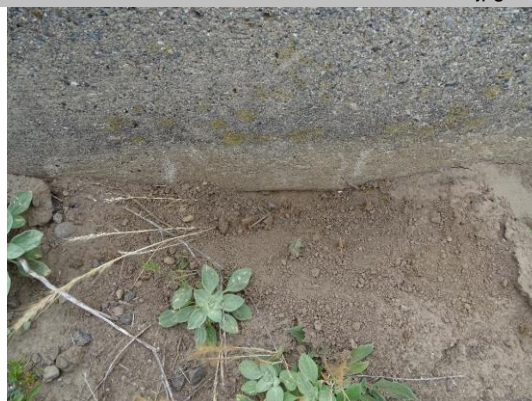
Photo 2 of 3 : UCIP_FA_2019_54011_79273.jpg

Comment Code						
Inspector Comment						
DS_ID:20877 FS_ID:54011 EP_NO: N/A Repair Type: Non-Urgent Crossing Status: Found UCIP Comments: 05/14/2019 Pipe outlet and headwall were excavated to evaluate pipe condition. Pipe is completely filled with soil that makes impossible to clear it for DMP internal video inspection. Pipe may be rehabilitated under DMP Phase II or removed. Excavated soil was backfilled. (O.Yakimov - DWR UCIP)Headwall covered with soil. Needs to be cleared at both ends. FIELD_STRUCT_DESC: 24-inch corrugated metal pipe through the levee 5-feet below the crown. Calco automatic drainage gate. Originally included in O+M manual (1957). As-built drawings available 50-4-2394. FS Date: 5/14/2019 8:37:31 AM

Concrete headwall on LS toe: top of pipe visible

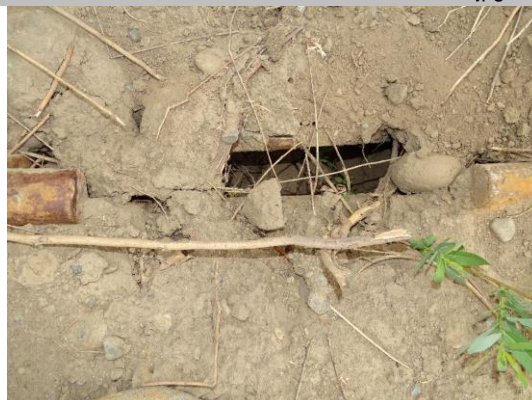
Photo 3 of 3 : UCIP_FA_2019_54011_79274.jpg

Pipe outlet discovered at WS toe. Visible gap between flap gate and pipe

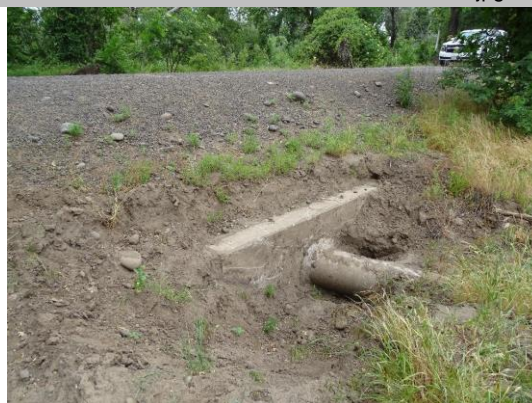
Photo 1 of 3 : UCIP_FA_2019_54012_79276.jpg

Comment Code					
Inspector Comment					
DS_ID:20767 FS_ID:54012 EP_NO: N/A Repair Type: Non-Urgent Crossing Status: Found UCIP Comments: 05/14/2019 Pipe outlet and headwall were excavated to evaluate pipe condition. Discovered a concrete pipe that connects nearby ditch with inlet of this crossing to drain water from the ditch. Cleared pipe outlet at WS toe. (O.Yakimov - DWR UCIP) Pipe blocked by soil. FIELD_STRUCT_DESC: 24-inch corrugated metal drainage pipe through the levee, 6 feet below the crown. Flap gate on the waterside (WS) end. [Additional Reference(s): DWR Levee Log, 1992. USACE Sacramento O&M Manual 509, March 1957, (Assumed Station 137+50) Drawing No. 50-4-2394]. FS Date: 5/14/2019 9:02:19 AM

Headwal and concrete pipe at LS toe

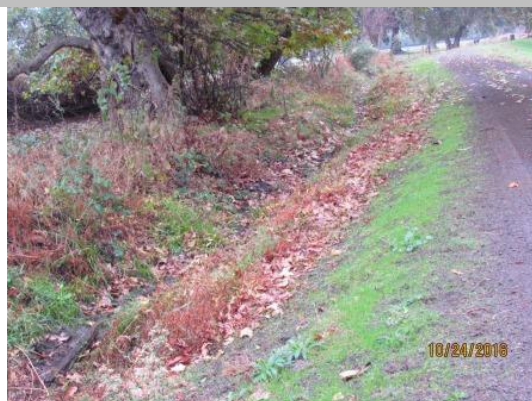
Photo 1 of 1 : FA_2019_NA0019_78_35_20190822_00011.jpg

View of the vegetation along the landside slope and toe.

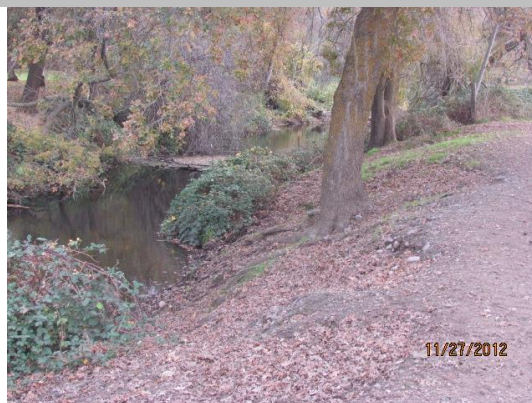
Photo 1 of 1 : FA_2019_NA0019_78_15_20190822_00003.jpg

View of the instability caused by livestock along the landside slope.

LM Start	3.68	Rating **	M	Issue No.	15
LM End	3.68	Issue Type +	Ma	Location *	LS
Category	Earthen Levee			GPS Latitude/Longitude	
				Start	End
Item	Slope Stability			39.945045 °	39.945045 °
				-122.053469 °	-122.053469 °
DWR ID	DWR_NA0019_01_f_2012_15				
Comment Code					
S1 : Repair slope instability.					
Inspector Comment

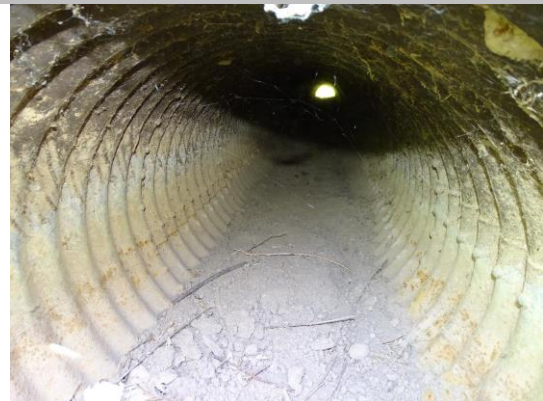
Photo 2 of 3 : UCIP_FA_2019_54024_79305.jpg

Comment Code						
Inspector Comment						
DS_ID:20762 FS_ID:54024 EP_NO: N/A Repair Type: Urgent Crossing Status: Found UCIP Comments: 05/14/2019 Missing flap gate, pipe outlet is silted. (O.Yakimov - DWR UCIP)10/15/2018 Missing flap gate at WS end of the pipe. Pipe is partially blocked with silt. Updated coordinates and CLM. (O.Yakimov - DWR)12/05/2016 unable to complete inspection -- unable to locate. (O. Magana - DWR UCIP)10/03/2013 Gate missing from WS toe. (W. Wylie - DWR UCIP) FIELD_STRUCT_DESC: 24-inch corrugated metal drainage pipe through the levee, 5.5 feet below the crown. Flap gate located on the waterside (WS) end. Concrete headwall located on the landside (LS) toe. [Additional Reference(s): DWR Levee Log, 1992. USACE Sacramento O&M Manual Unit 509, March 1957, As-built drawing no. 50-4-2394 (Station 0+65)]. FS Date: 5/14/2019 11:01:16 AM

Inside view of pipe looking from LS

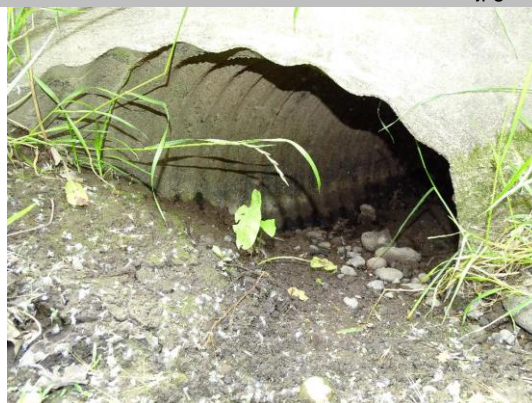
Photo 1 of 3 : UCIP_FA_2019_53997_79240.jpg

Comment Code						
Inspector Comment						
DS_ID:20771 FS_ID:53997 EP_NO: N/A Repair Type: Non-Urgent Crossing Status: Found UCIP Comments: 05/14/2019 Pipe is 50% silted throughout its entire lenght. Flap gate on WS is partially buried in mud that affects proper operation, visible gap between flap gate and pipe. Pipe crosses levee at an angle. (O.Yakimov - DWR UCIP)12/05/2016 Crossing has been downgraded from Urgent to Non-Urgent some debris blocking proper function of flapgate on WS. Recommend clearing debris from WS for flapgate to function properly. (O. Magana - DWR UCIP)10/01/2013 Debris blocking proper function of flapgate on WS toe. (W. Wylie - DWR UCIP) FIELD_STRUCT_DESC: 24-inch steel drainage pipe through the levee, 8.3 feet below the crown. Flap gate located on the waterside (WS) end. Concrete headwall located on the landside (LS). [Additional Reference(s): DWR Levee Log, 1992. USACE Sacramento O&M Manual Unit 509, March 1957, Unit 510, April 1963, Unit 511, May 1973, Unit 512, March 1964, Unit 513, December 1970, As-builts drawing 50-4-2394 (Station 155+40)]. FS Date: 5/14/2019 1:15:18 PM

View of pipe from LS

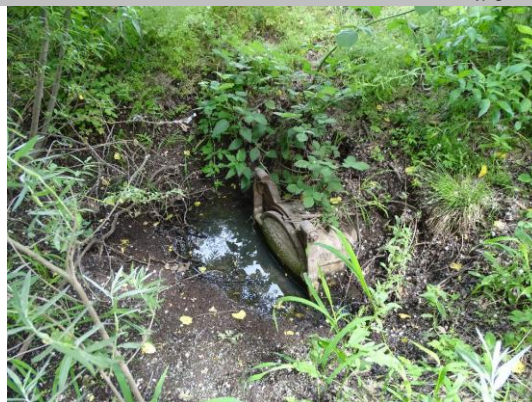
Photo 2 of 3 : UCIP_FA_2019_53997_79241.jpg

Flapgate on WS outlet

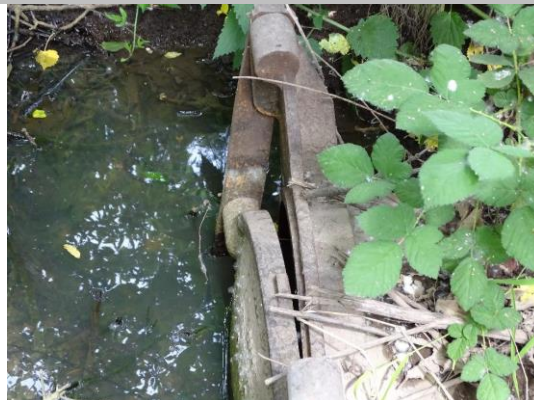
Photo 3 of 3 : UCIP_FA_2019_53997_79238.jpg

Comment Code						
Inspector Comment						
DS_ID:20771 FS_ID:53997 EP_NO: N/A Repair Type: Non-Urgent Crossing Status: Found UCIP Comments: 05/14/2019 Pipe is 50% silted throughout its entire lenght. Flap gate on WS is partially buried in mud that affects proper operation, visible gap between flap gate and pipe. Pipe crosses levee at an angle. (O.Yakimov - DWR UCIP)12/05/2016 Crossing has been downgraded from Urgent to Non-Urgent some debris blocking proper function of flapgate on WS. Recommend clearing debris from WS for flapgate to function properly. (O. Magana - DWR UCIP)10/01/2013 Debris blocking proper function of flapgate on WS toe. (W. Wylie - DWR UCIP) FIELD_STRUCT_DESC: 24-inch steel drainage pipe through the levee, 8.3 feet below the crown. Flap gate located on the waterside (WS) end. Concrete headwall located on the landside (LS). [Additional Reference(s): DWR Levee Log, 1992. USACE Sacramento O&M Manual Unit 509, March 1957, Unit 510, April 1963, Unit 511, May 1973, Unit 512, March 1964, Unit 513, December 1970, As-builts drawing 50-4-2394 (Station 155+40)]. FS Date: 5/14/2019 1:15:18 PM

Flapgate gap due to sediment buildup at the bottom of pipe

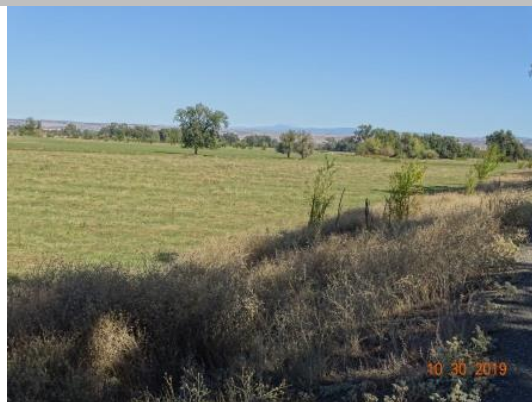
Photo 1 of 1 : FA_2019_NA0019_79_10_20191101_00016.jpg

View of the vegetation along the landside slope. Fall 2019.

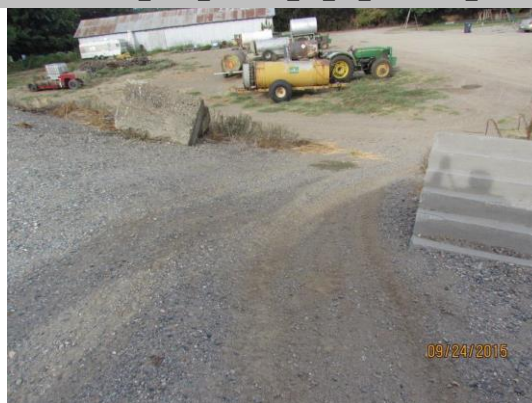
Photo 1 of 1 : FA_2019_NA0019_81_25_20190822_00014.jpg

View of the slope instability caused by vehicles along the landside slope.

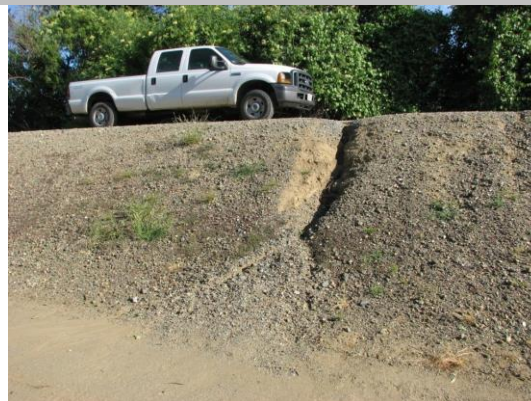
Photo 1 of 1 : FA_2019_NA0019_82_10_20190822_00005.jpg

View of the erosion along the landside slope.
